FIRE ENDURANCE TESTS OF PLYWOOD ON STEEL JOIST FLOOR ASSEMBLIES, WITH AND WITHOUT CEILING

(Test Numbers 492, 497)

H. Shoub, B. C. Son

March 1973

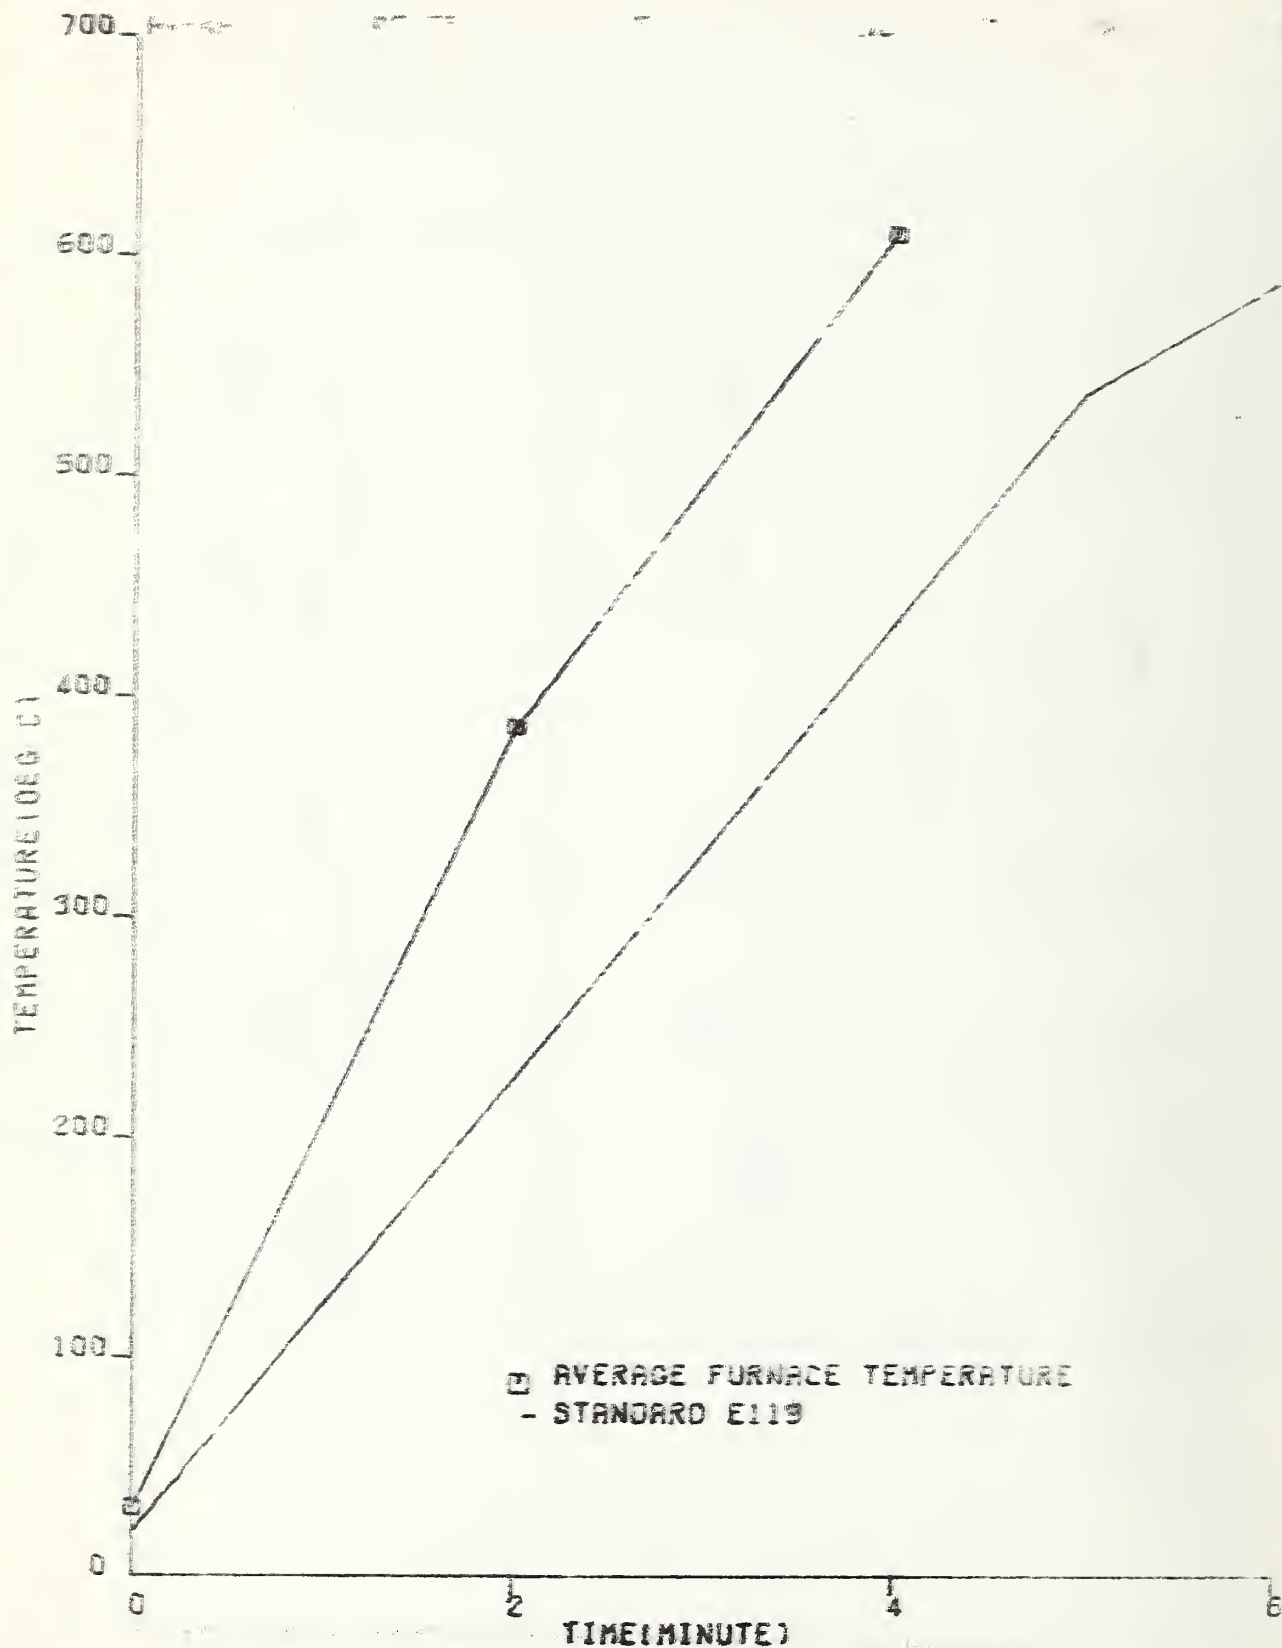
Figure 9 - FLOOR OVER FOUNDATION SPACE - AVERAGE FURNACE TEMPERATURE COMPARED WITH STANDARD E 119 CURVE

The ASTM E 119 fire test standard requires compensation for fire exposures deviating from the standard time-temperature relation only if indicated failure times are 1/2-hr. or greater. As the fire exposure severity in this case was appreciably greater than that required by the standard (figure 9), it was appropriate to apply corrections for the times to the two modes of failure despite their brevity. Applying these corrections estimates to the results, the end point times become 3 min. 30 sec. and 4 min. 5 sec. for flame through and failure to sustain load, respectively.

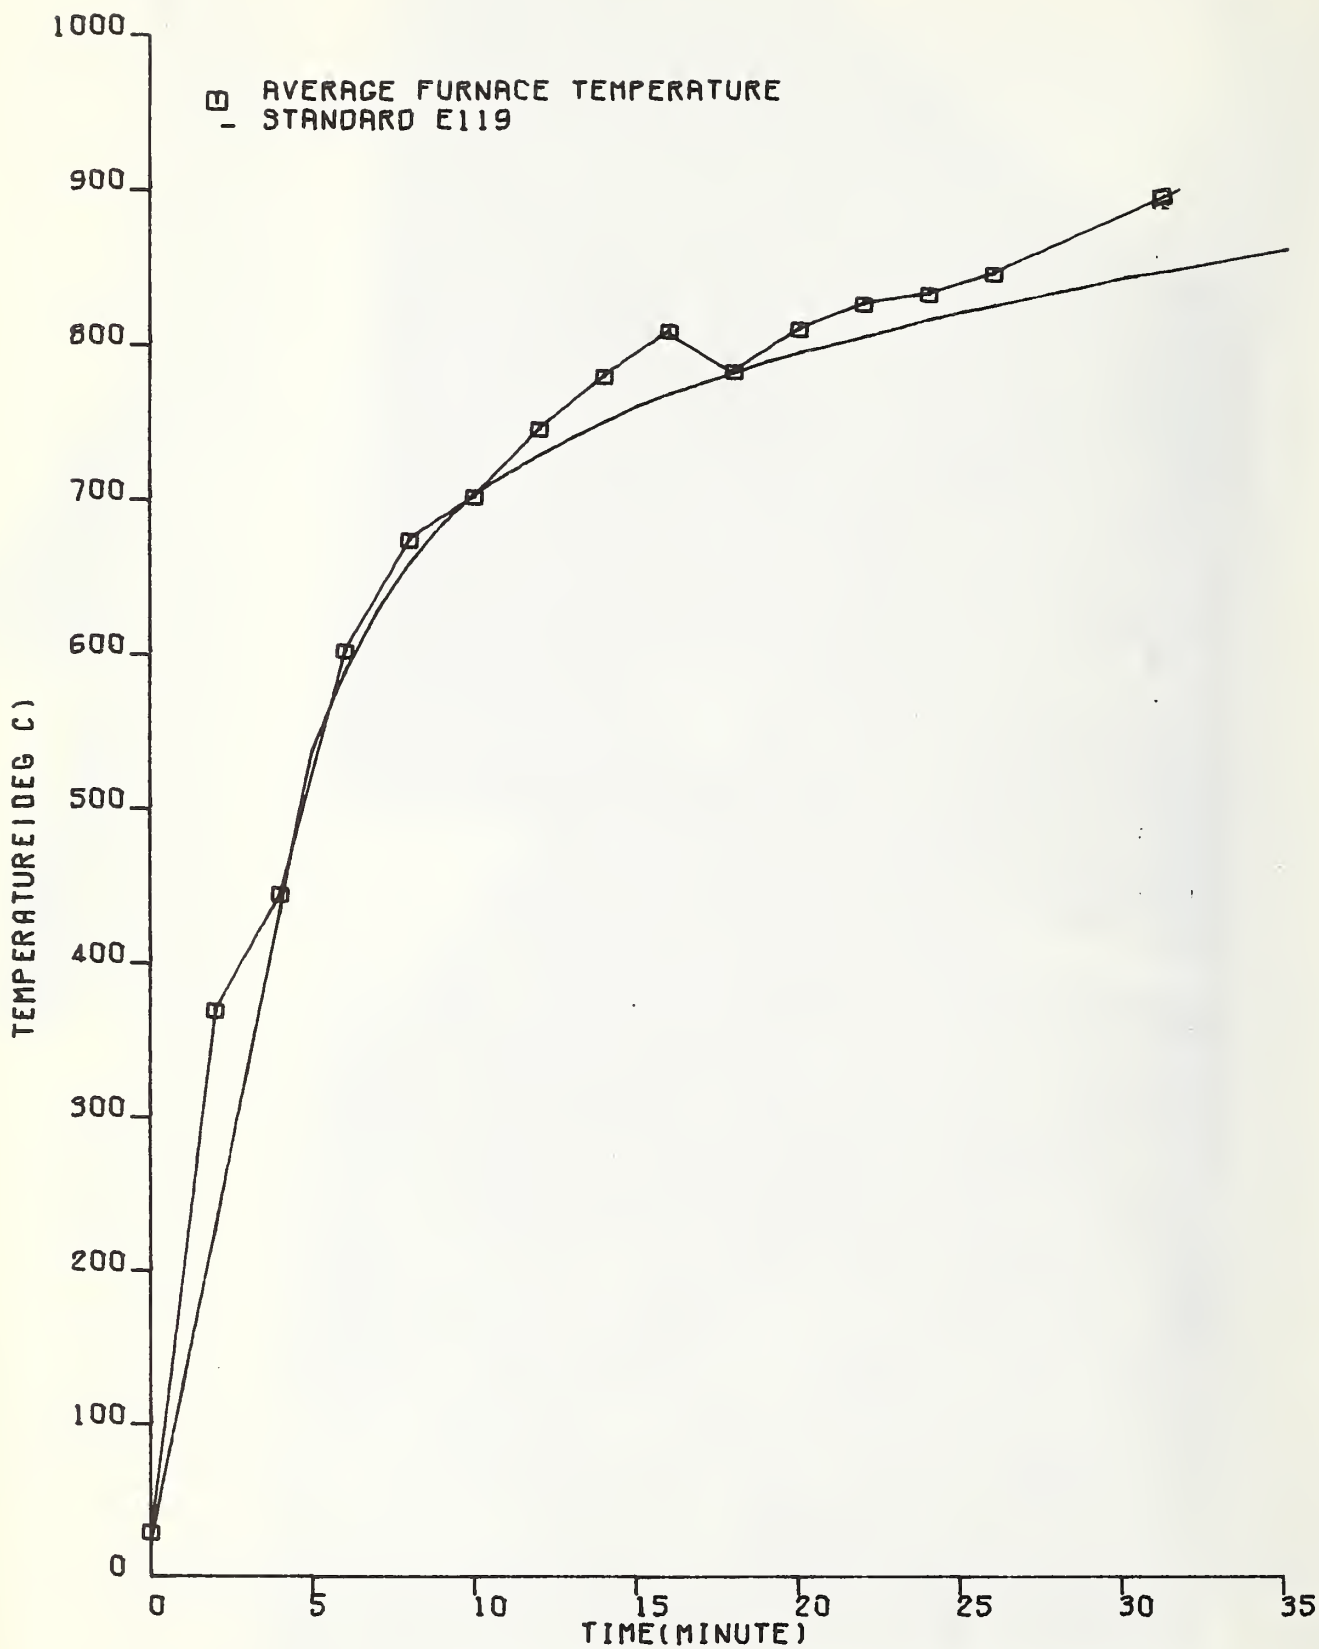
Figure 13 - FLOOR-CEILING ASSEMBLY - AVERAGE FURNACE TEMPERATURE COMPARED WITH STANDARD E 119 CURVE,

For the floor-ceiling assembly, failure occurred at 29 min. after start of the test by passage of flame through to the unexposed surface. At 33 min., local collapse of the assembly was observed at the end away from the ductwork and diffusers. As can be seen in figure 13 the actual fire exposure severity was slightly greater than that specified in the
